DNAPL Investigation Status Summary

Detrex Site – Ashtabula, Ohio

APRIL 2012

Prepared by
URS Corp.
Cleveland Office

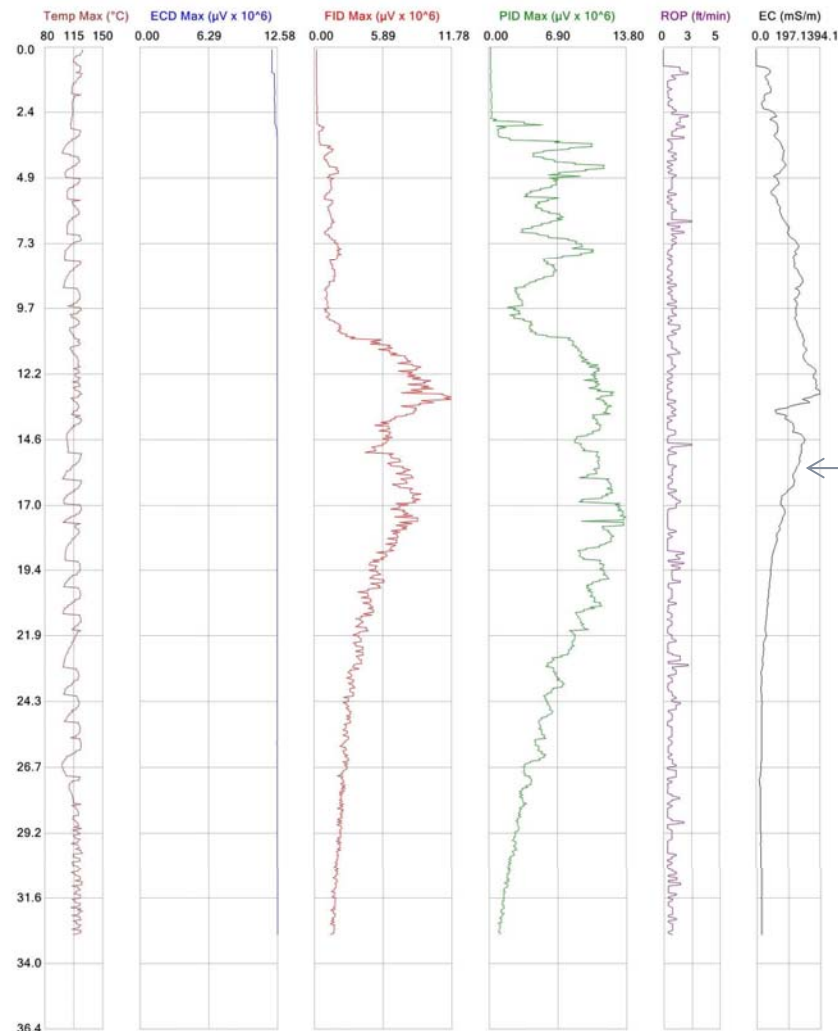
MIP – 15 Log
(inside lagoon area)

Fill to 16.0 ft
Gray silts / clays

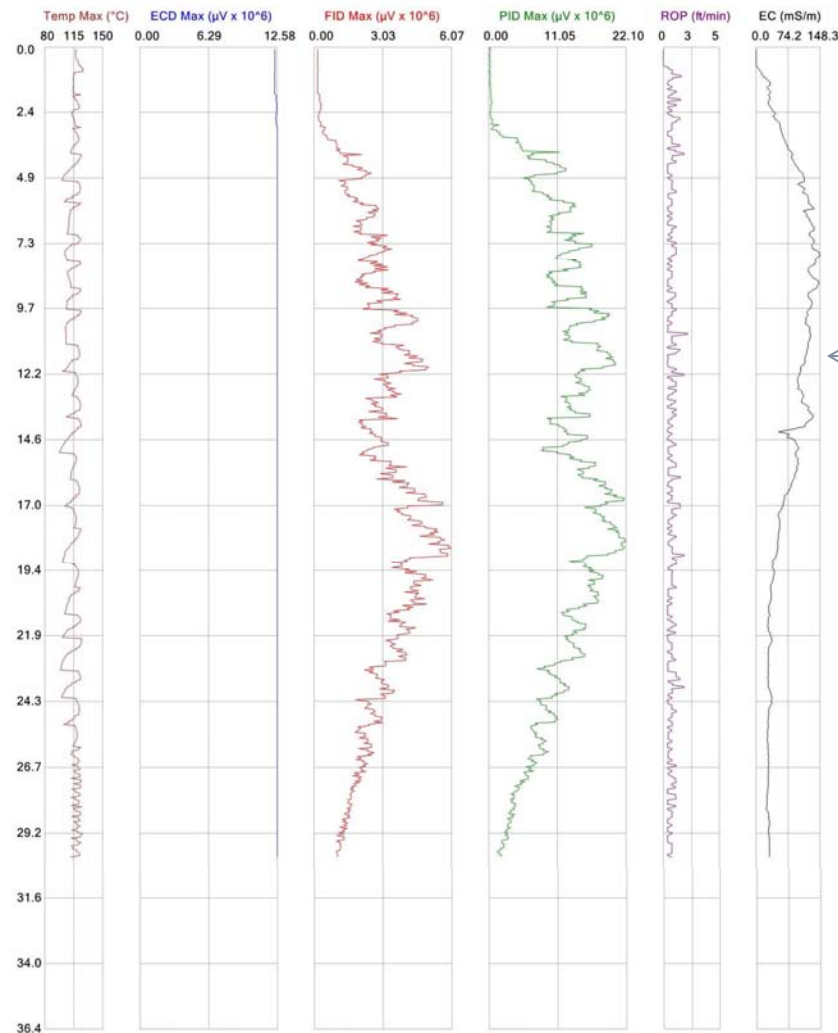
MIP – 24 Log
(natural soils, south
of lagoon)

← Brown clay soils

Gray clay

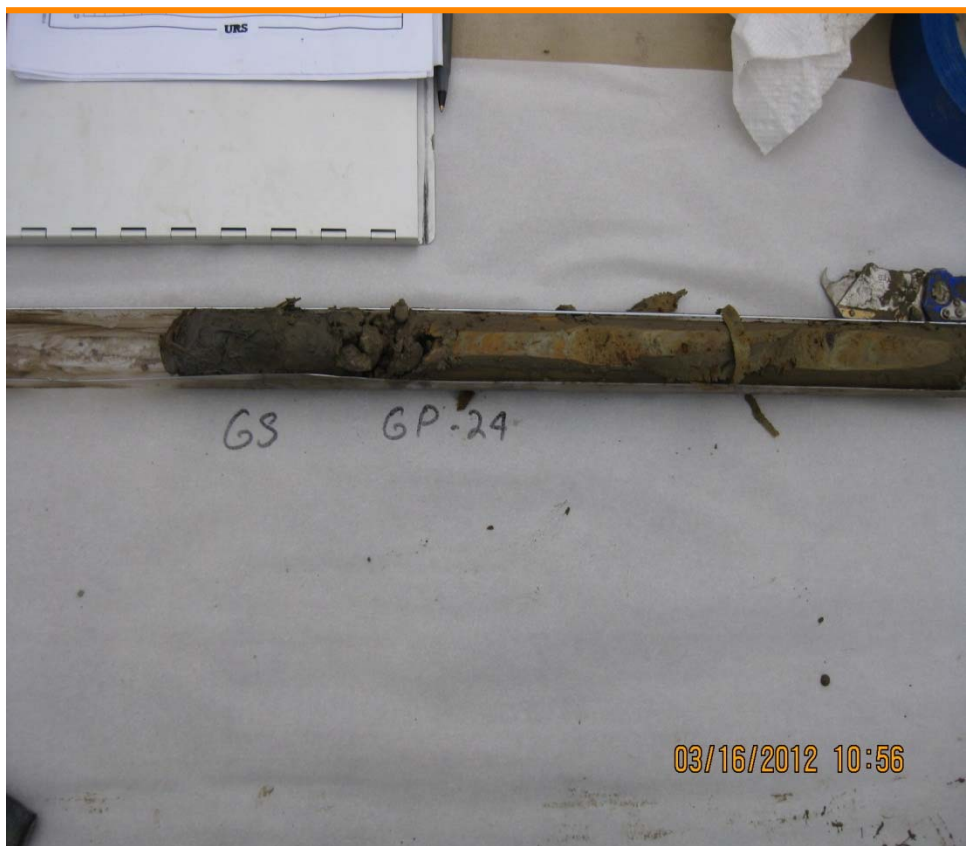
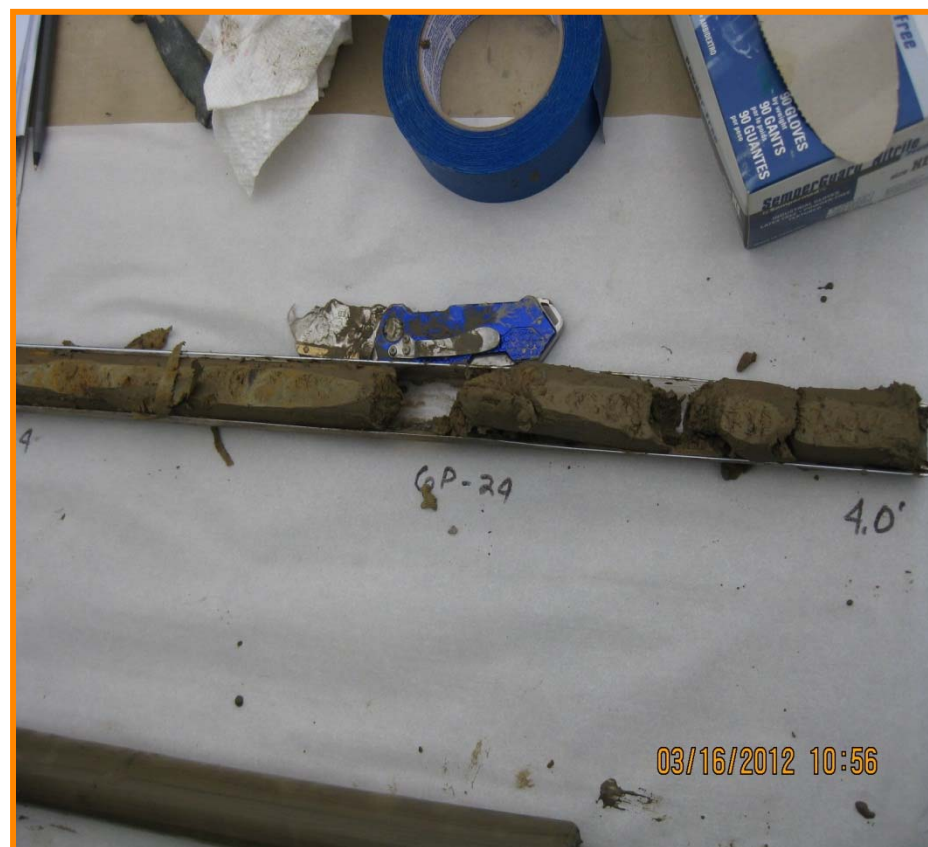
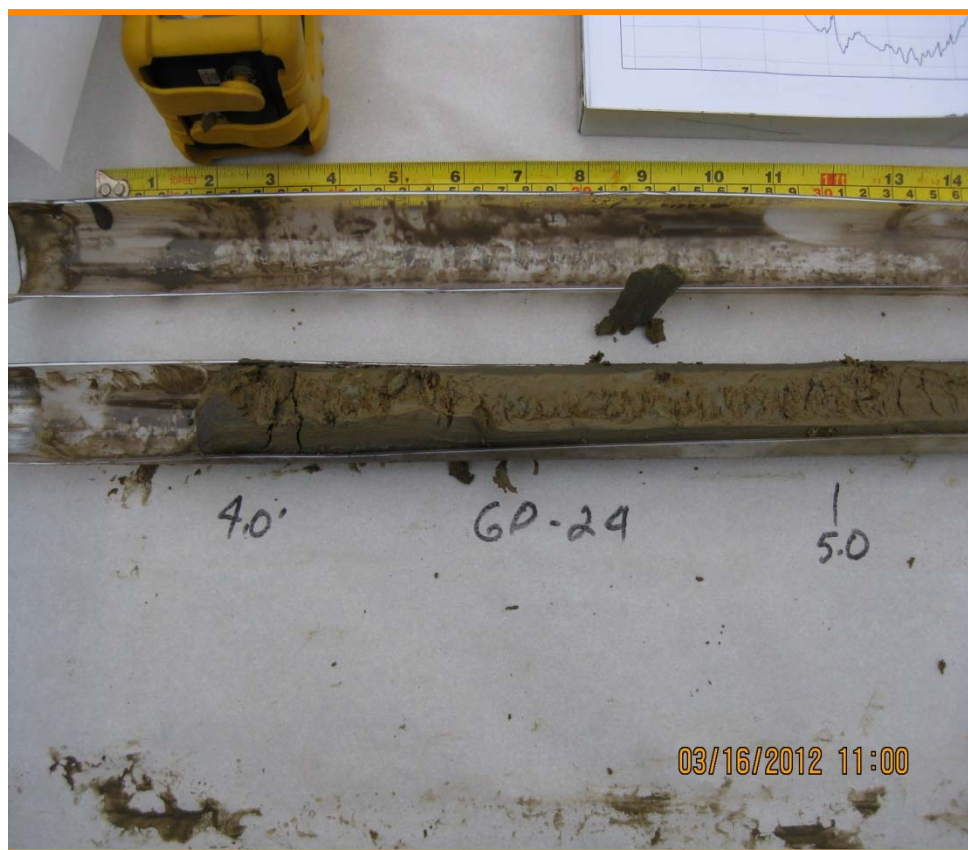
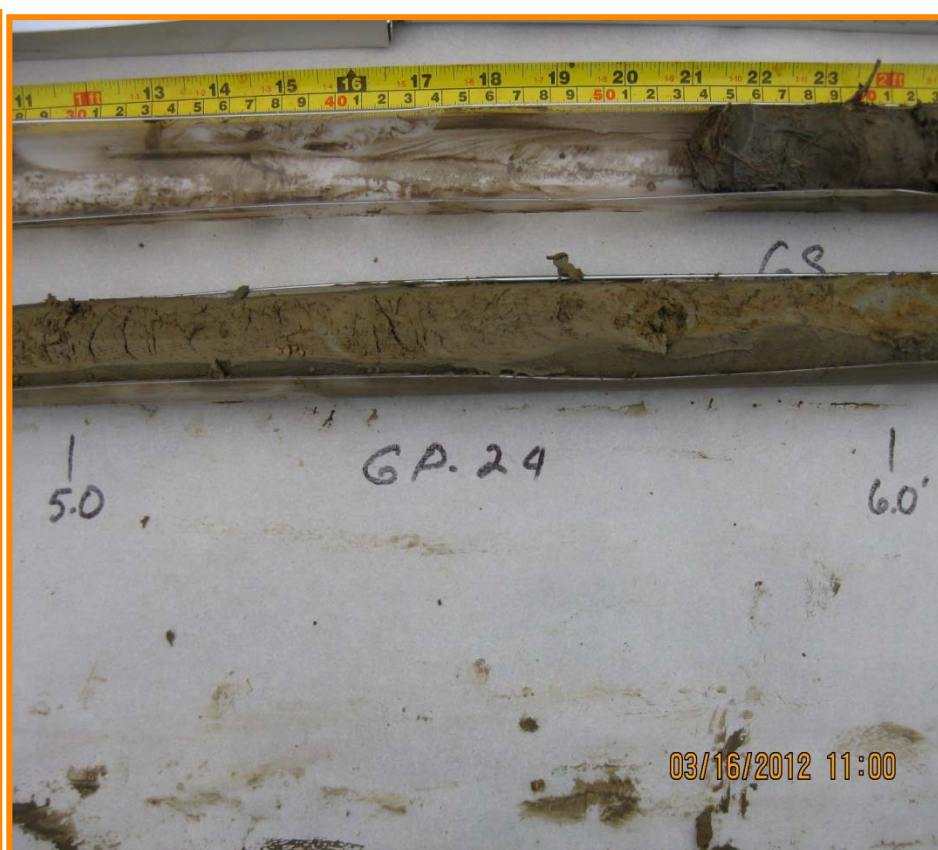
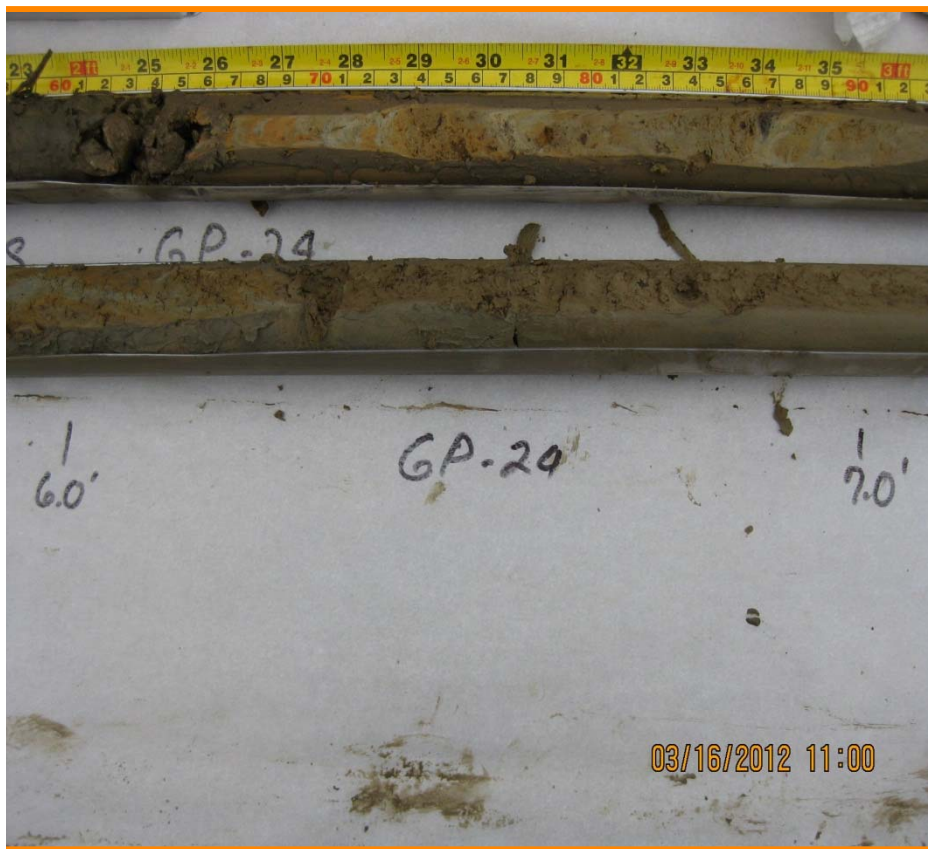
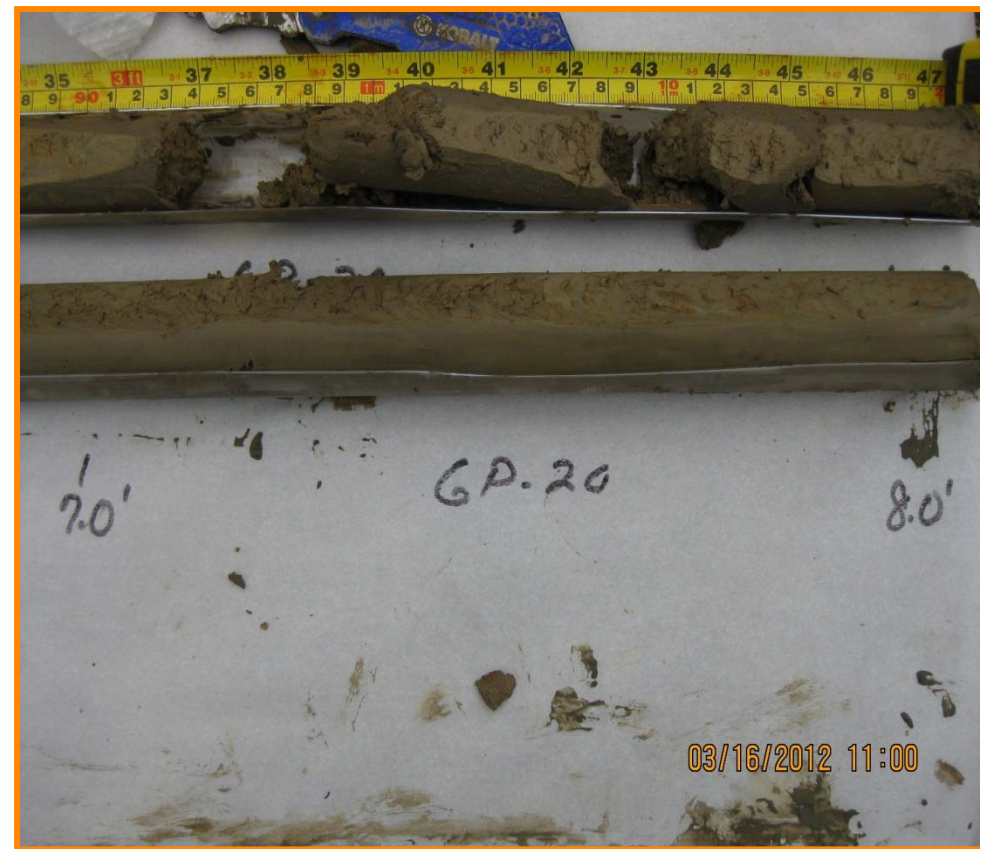
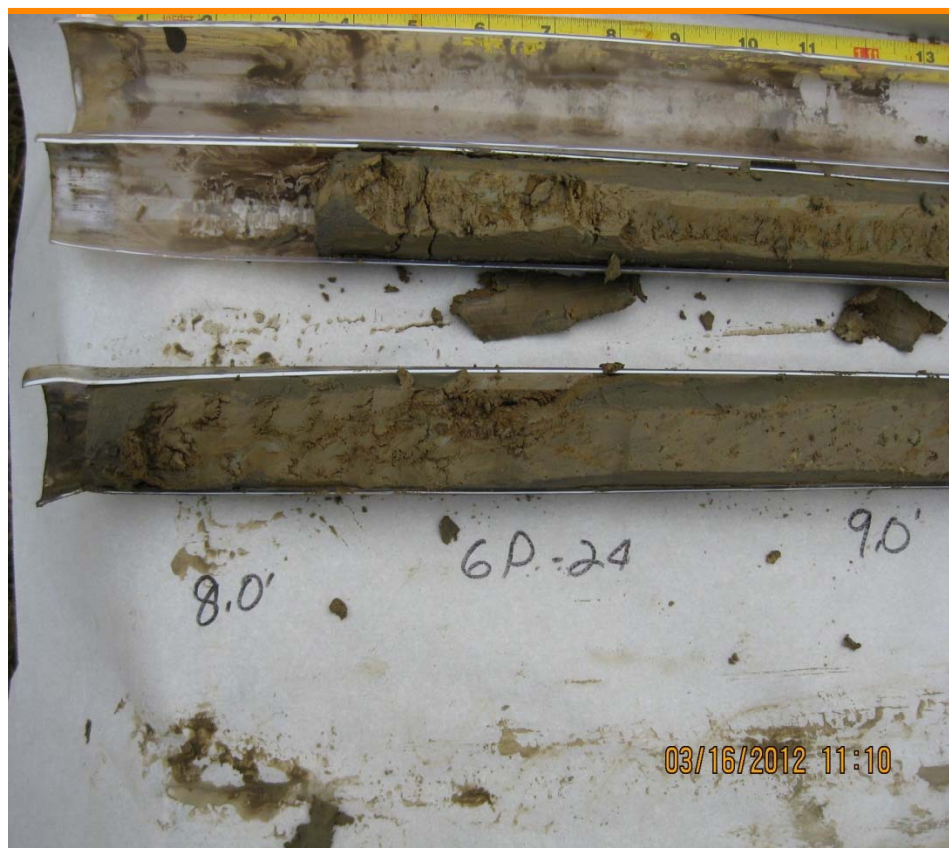
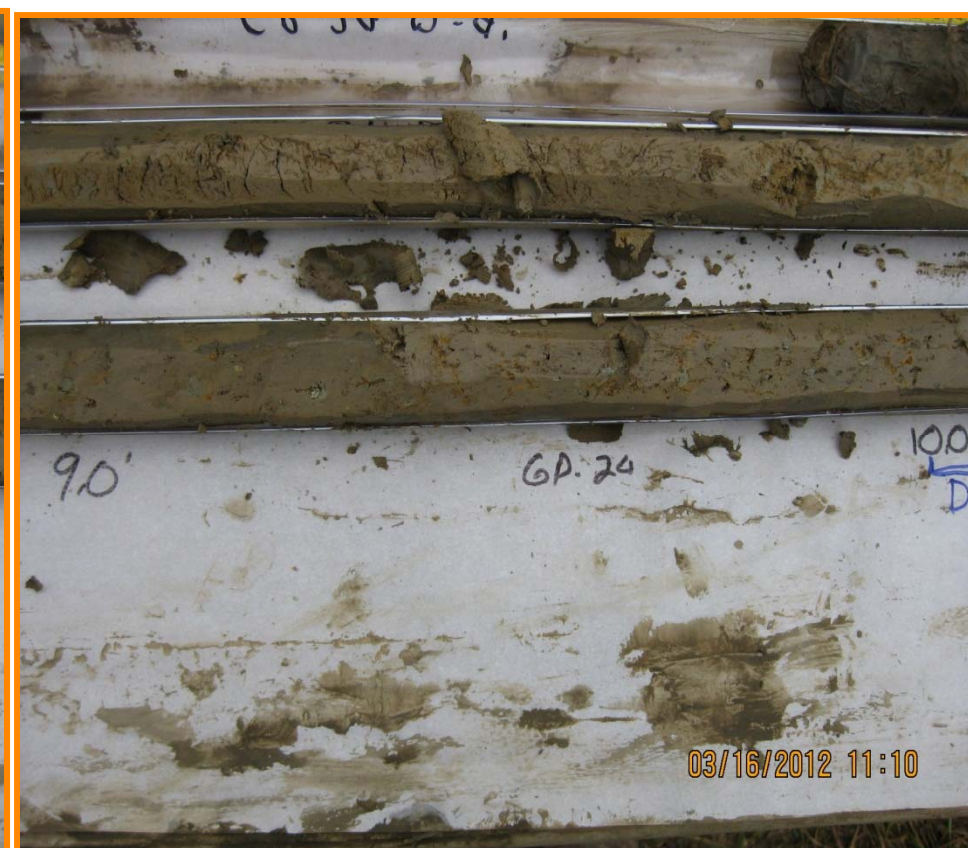
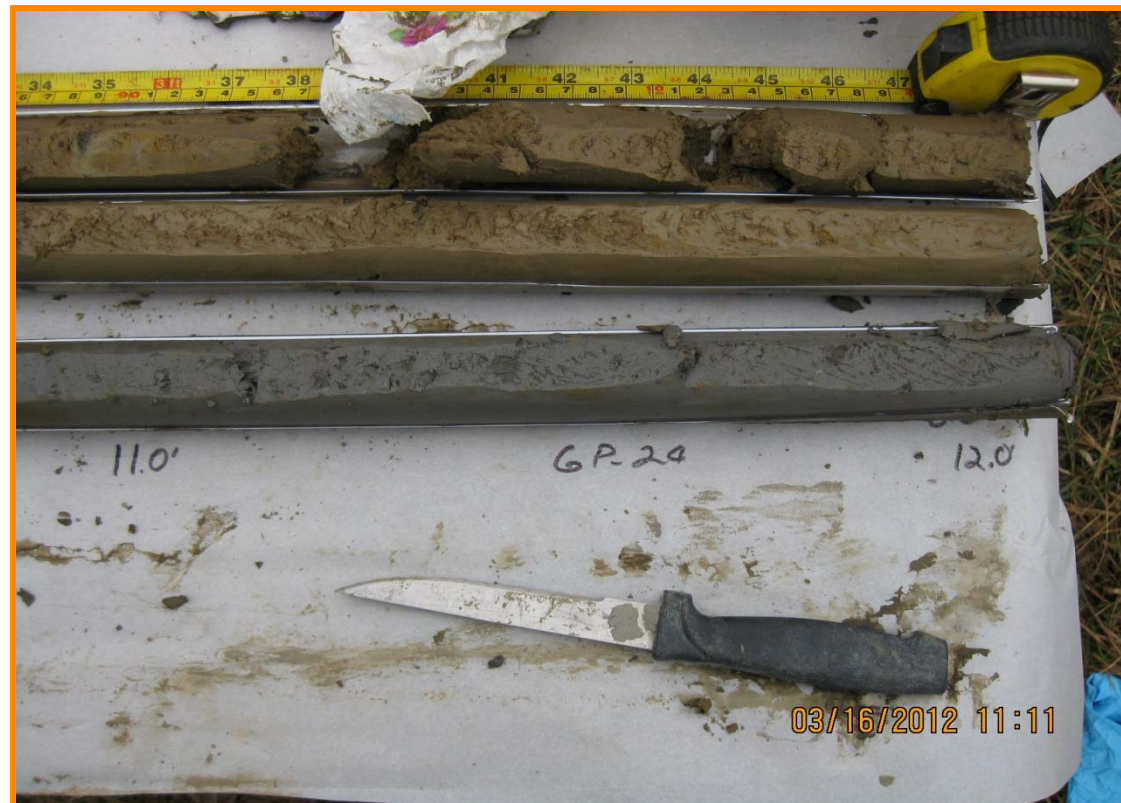
GP-24 Photos

- Soil borings logged continuously, photographed, and inspected
 - Former Lagoon Area
 - GP-15: 0-20 ft, clay fill to 16.0 ft, DNAPL seep at 9.0 ft, sheen and DNAPL seeps at 19.0 ft
 - GP-24: 0-11 ft, natural clay soil, DNAPL seep at 10 ft
 - GP-30: 0-20 ft, natural clay soil, DNAPL sheen at 15-16 ft
 - Within Plant Area
 - GP-04: 0-16 ft, natural clay soil, DNAPL sheen at 10.0 – 10.5 ft
 - GP-26: 0-16 ft, natural clay soil, DNAPL sheen at 5.0 - 6.0 ft, DNAPL sheen at 8.0 – 9.0 ft
 - GP-29: 0-8 ft, clay fill to 3 ft, natural clay soil to 8 ft
 - Outside Plant Area
 - GP-34: 0-10 ft, natural clay soil, no sheen, vapor or DNAPL
 - DNAPL observed in thin, discontinuous voids / cracks and in water saturated silt lenses
 - Sheen observed in thin (1-2 ft thick), discontinuous, water saturated lenses within clay soil matrix

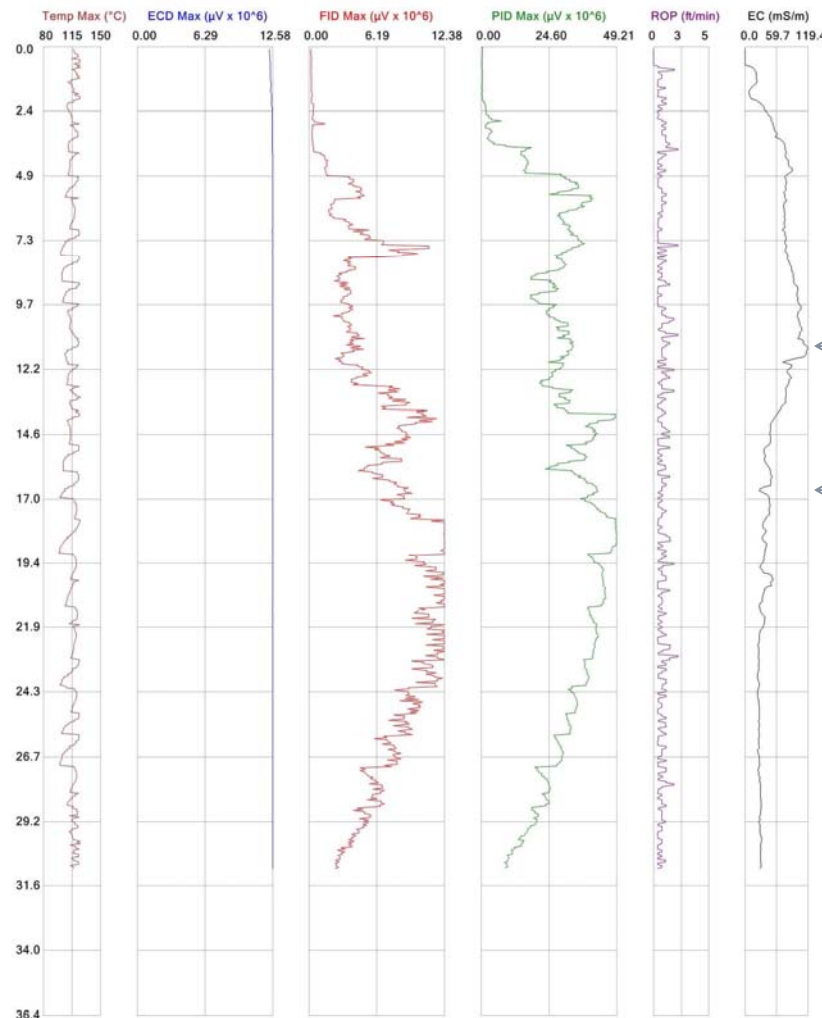
MIP – 30 Log
(natural soils, south
of lagoon)

Brown clay

Gray silty clay, laminated

Gray silty clay, glacial till

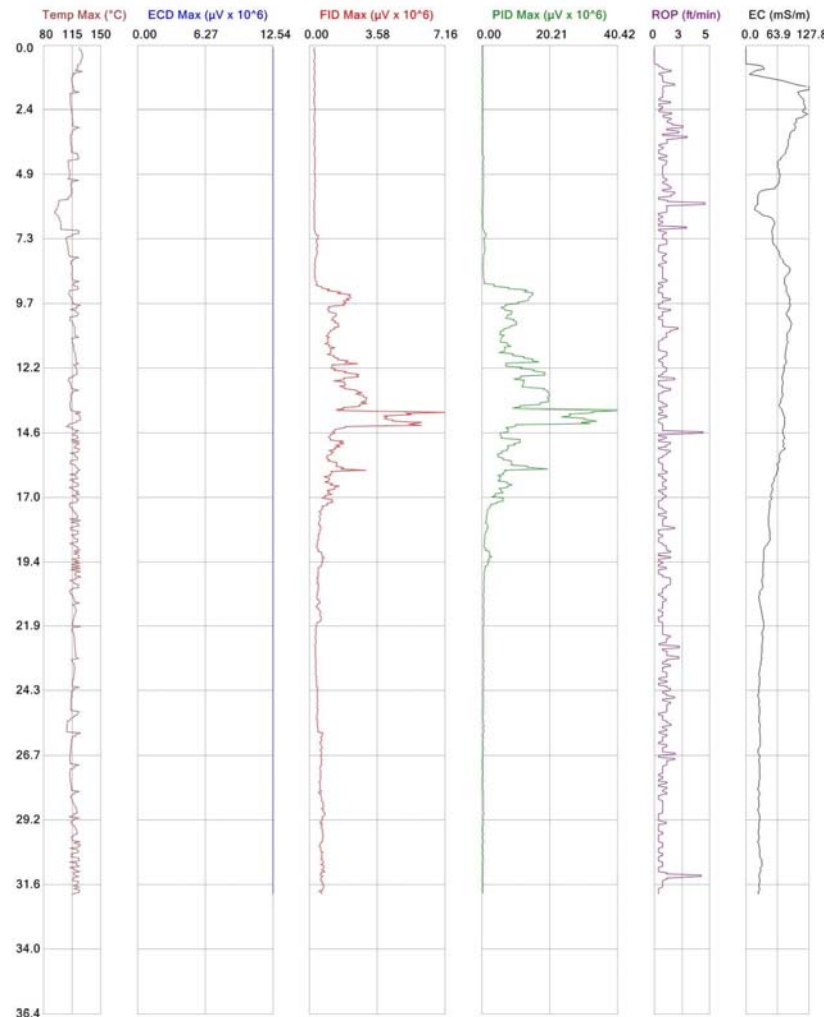
MIP – 04 Log
(fill, natural soils,
north plant area)

← Fill

Brown clays, laminated

Gray silty clay, laminated

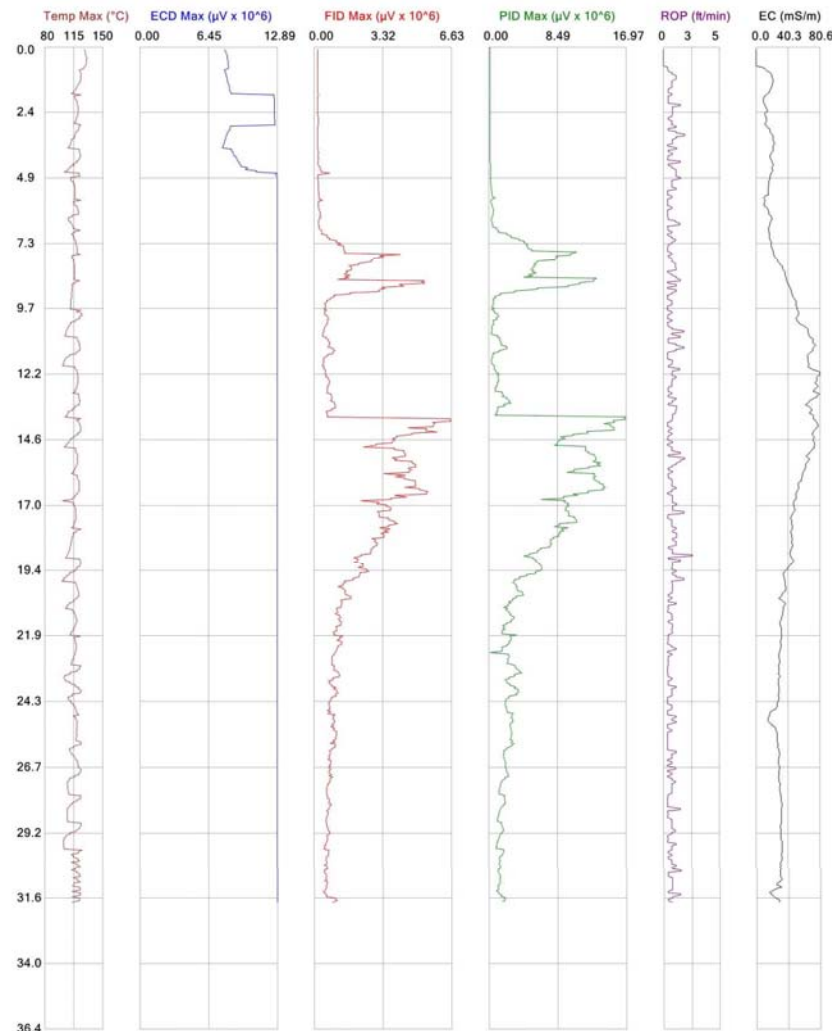
MIP – 26 Log
(natural soil, plant)

Brown clay

Gray silty clay

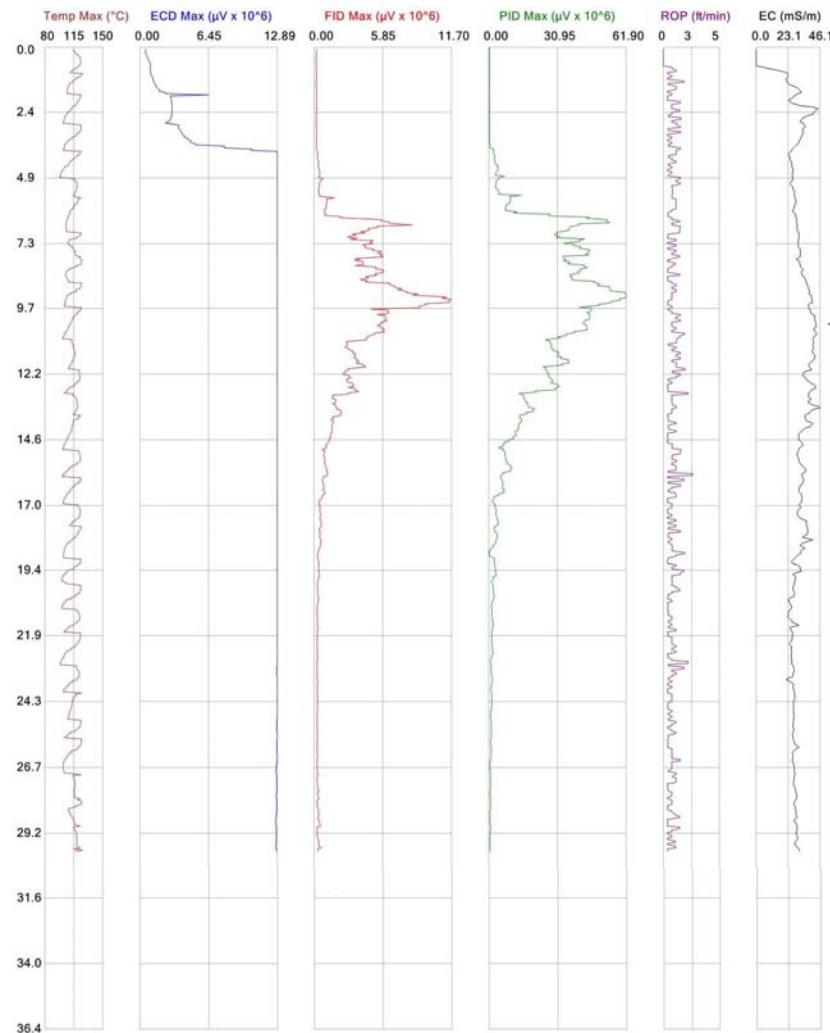
MIP – 29 Log (natural soils, plant)

Brown clay

Gray silty clay

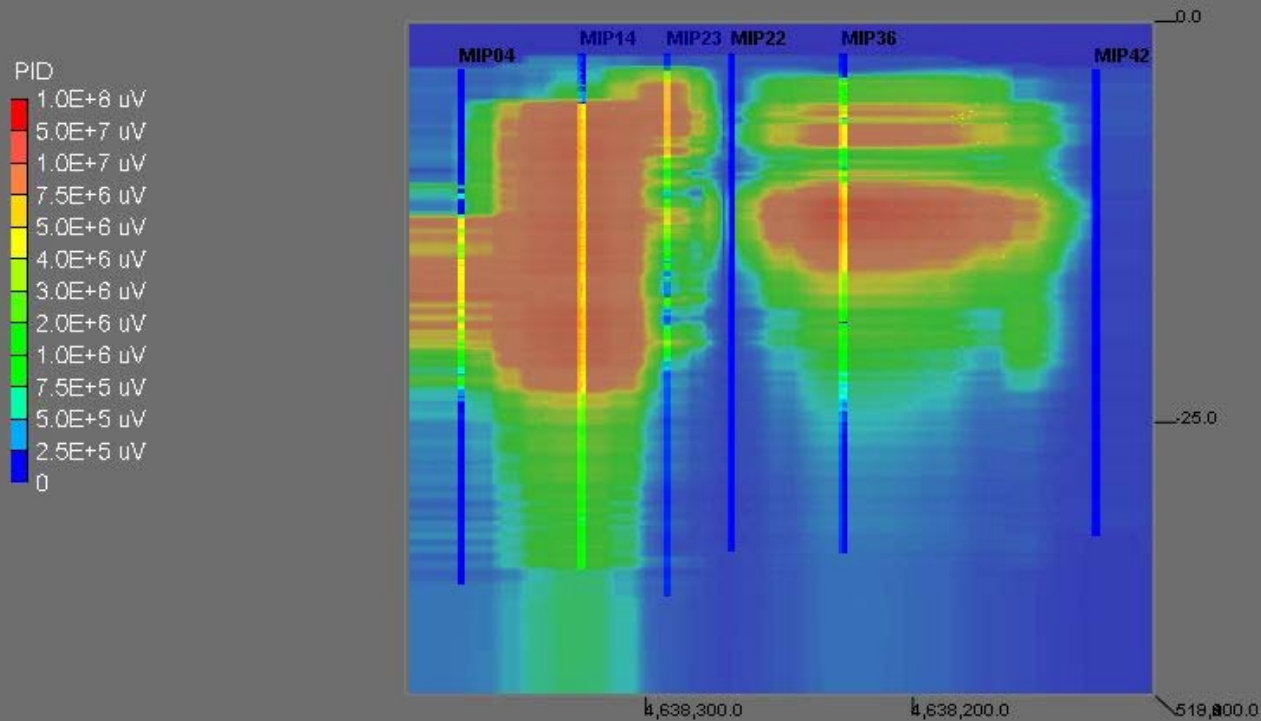
Cross Section -- North-South View 04-42 -- Plant Area

- Oblique View
 - 2 screening levels (33.5×10^6 and 25×10^6) max PID was 68×10^6 at MIP 36 (AST area)
- Overhead Mapping
 - 2 screening levels (33.5×10^6 and 25×10^6)
- Cross Sections
 - 2 North-South (Elevated PID at 5-15 ft and above 25 ft)
 - 1 East-West (Elevated PID above 25 ft, except lagoon area)
